EQUIPMENT DEVELOPMENT & TEST REPORT 5100-17

# CATALYTIC CONVERTER EXHAUST SYSTEM TEMPERATURE TESTS

**Robin T. Harrison**  
*Mechanical Engineer*

Forest Service, U. S. Department of Agriculture  
Equipment Development Center, San Dimas, California 91773

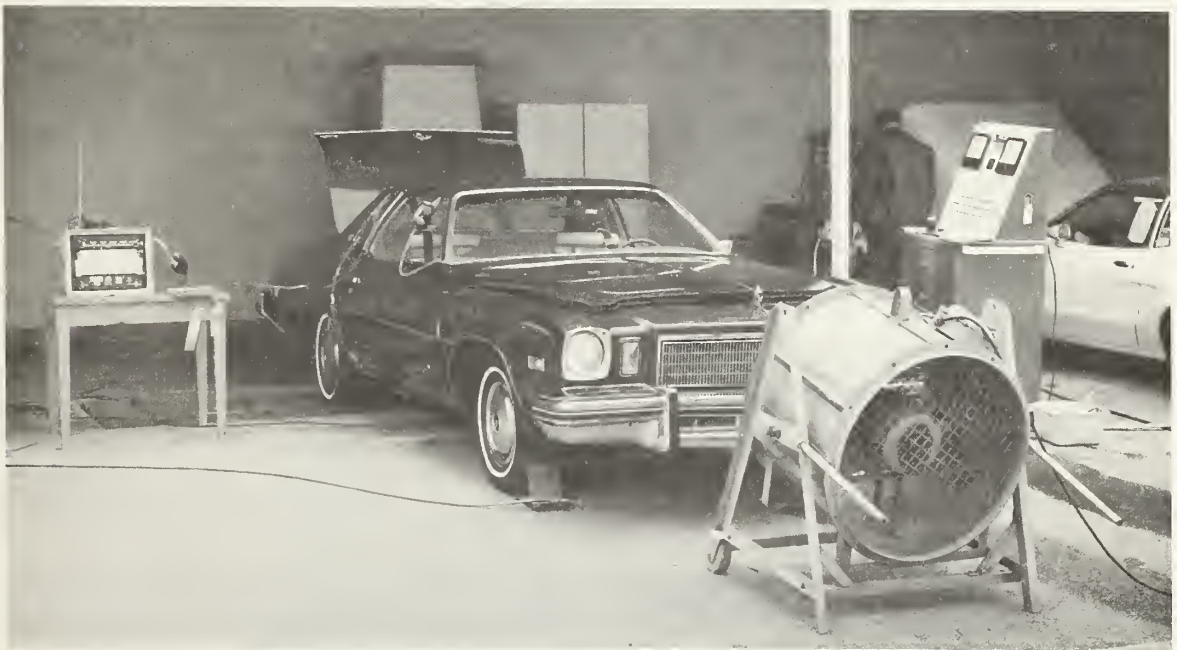
Dynamometer tests simulating running vehicles under different road conditions were made. The modes and conditions they were intended to simulate are described in table 2. Figure 1 shows a test vehicle in place on the dynamometer.

*Figure 1. Test vehicle undergoing dynamometer phase of test program.*

A 15-hp axial fan provided cooling during the dynamometer tests. It is recognized that this fan did not provide wind velocities comparable to those obtained during the road tests (2). The fan was positioned with its axis parallel to the waistline of the test vehicle and the front of the fan assembly 18 inches directly in front of the vehicle grill.
